**Upper Hutt Central  
Business Area**

*Safety Assessment  
and  
Crime Prevention Plan*

**Safety Assessment**  
and  
**Crime Prevention Plan**  
**Upper Hutt CBD Area**

**STOKS LIMITED**  
**ENVIRONMENTAL SECURITY**

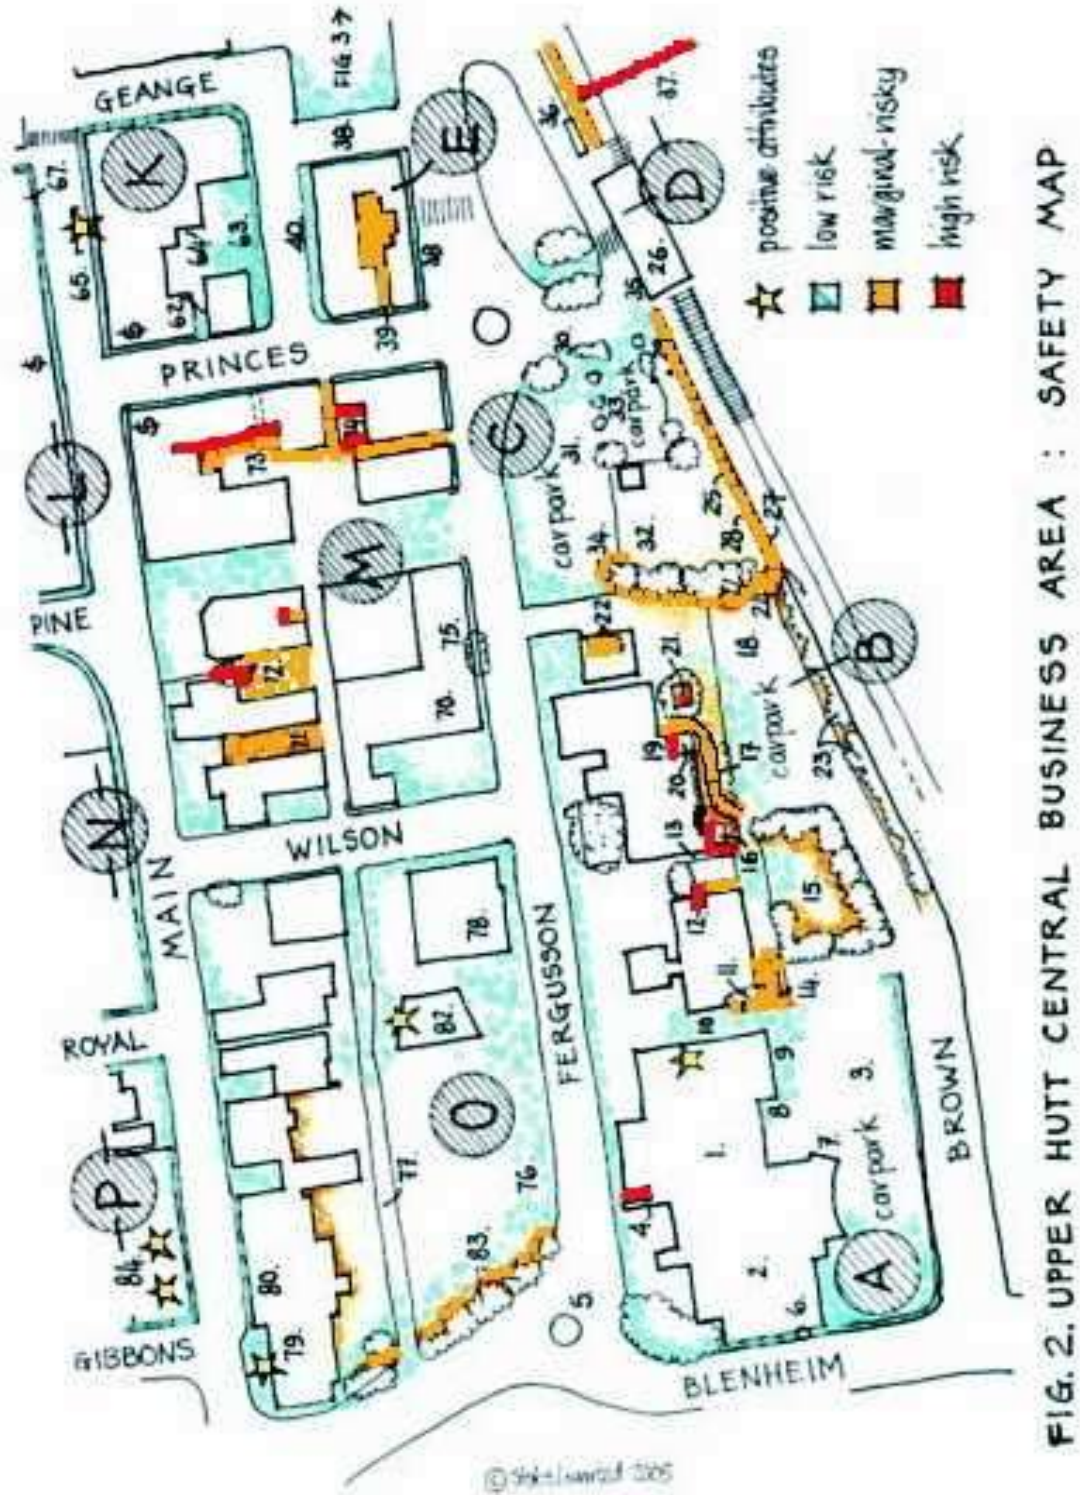
Fig.2: Safety Map 1 of Upper Hutt CBD

The findings from the assessments have been recorded on a Safety Map prepared shown in Fig. 2 and Fig. 3. The Safety Map is based on the assessment criteria described in Section 2.5. The marking and shading of the maps may be interpreted as follows:

The areas shown in orange are places considered to be relatively safe, but may cause some users to feel insecure. Places where loss of a single light is likely to reduce illuminance significantly are also given this designation. These areas are recommended for upgrading as an important, but not necessarily critical priority.

The areas shown in red are places considered to be potentially dangerous especially after dark. They are very likely to engender fear of crime. It is strongly recommended that safety and security of these areas be attended to as a matter of priority.
